B&G COMMITTEE UPDATE to Board 09/26/2024

Windstar on Naples Bay
Hamilton Ave Entry
Collier County, FL
EXISTING CONDITIONS PLAN

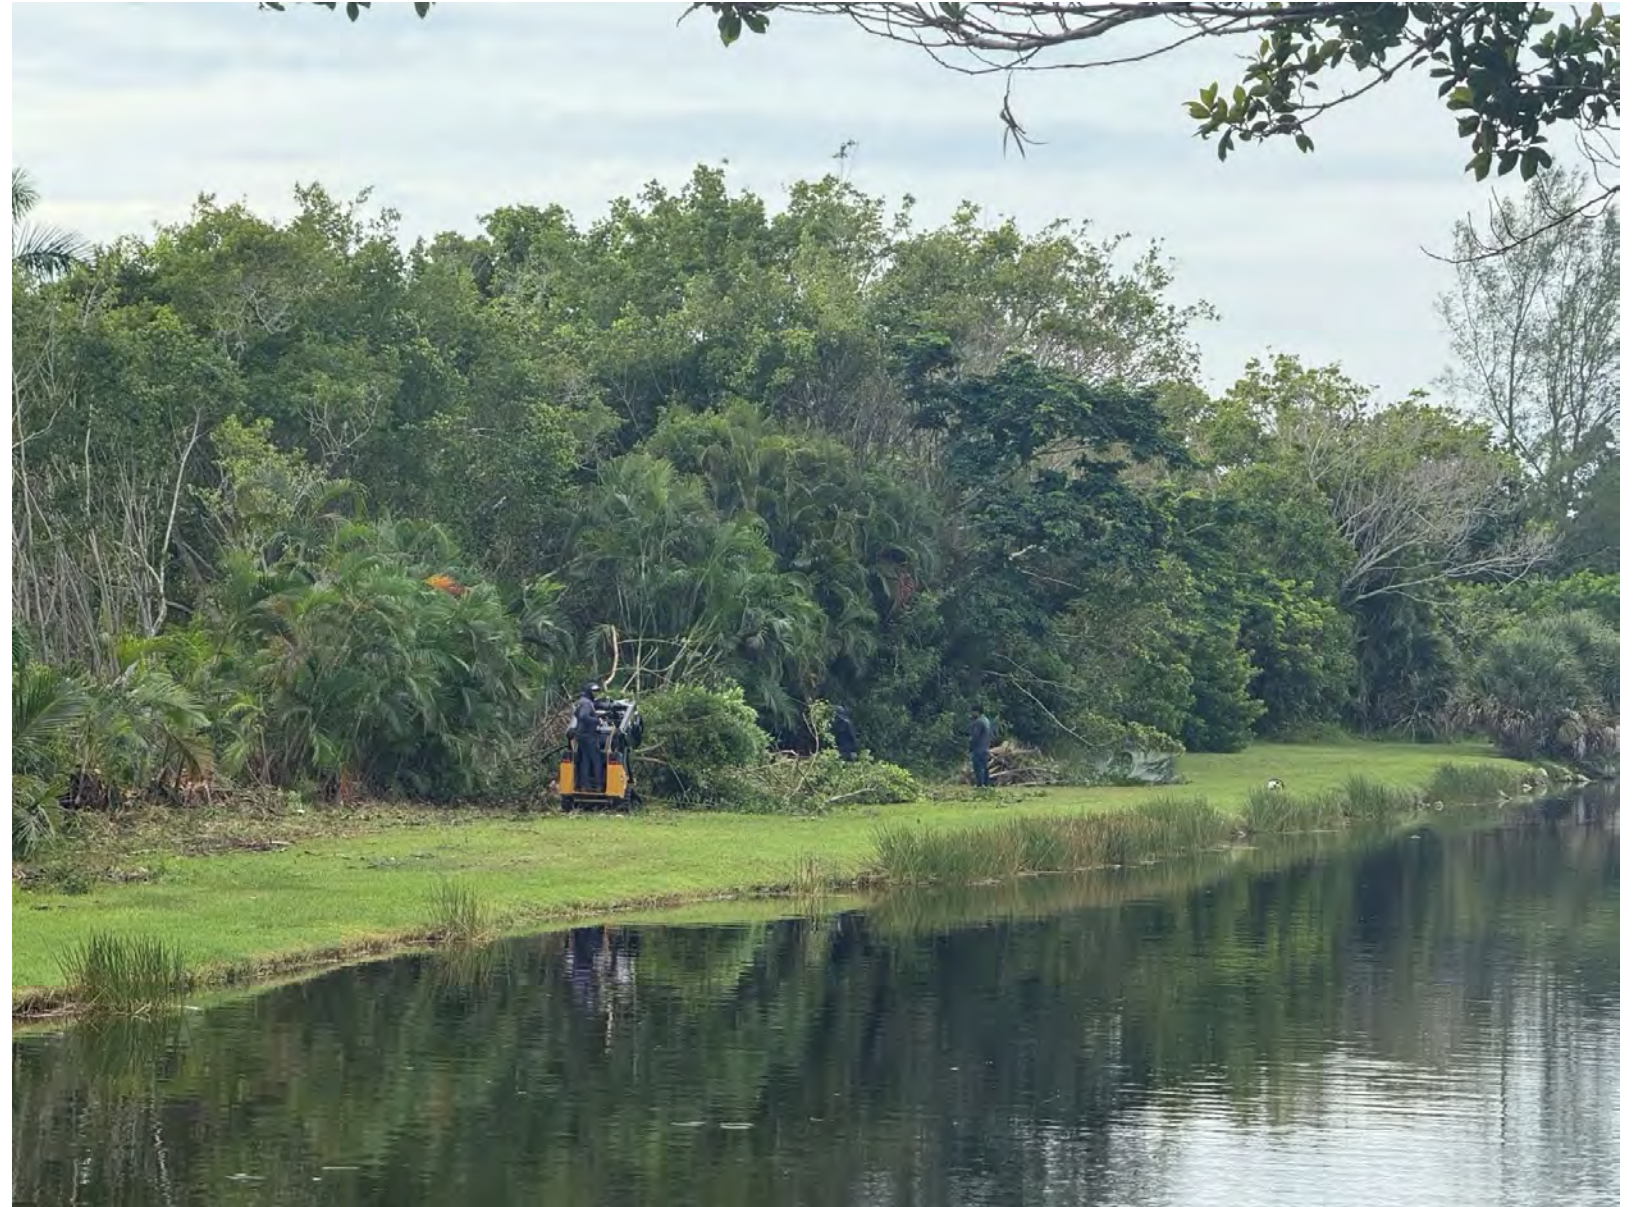
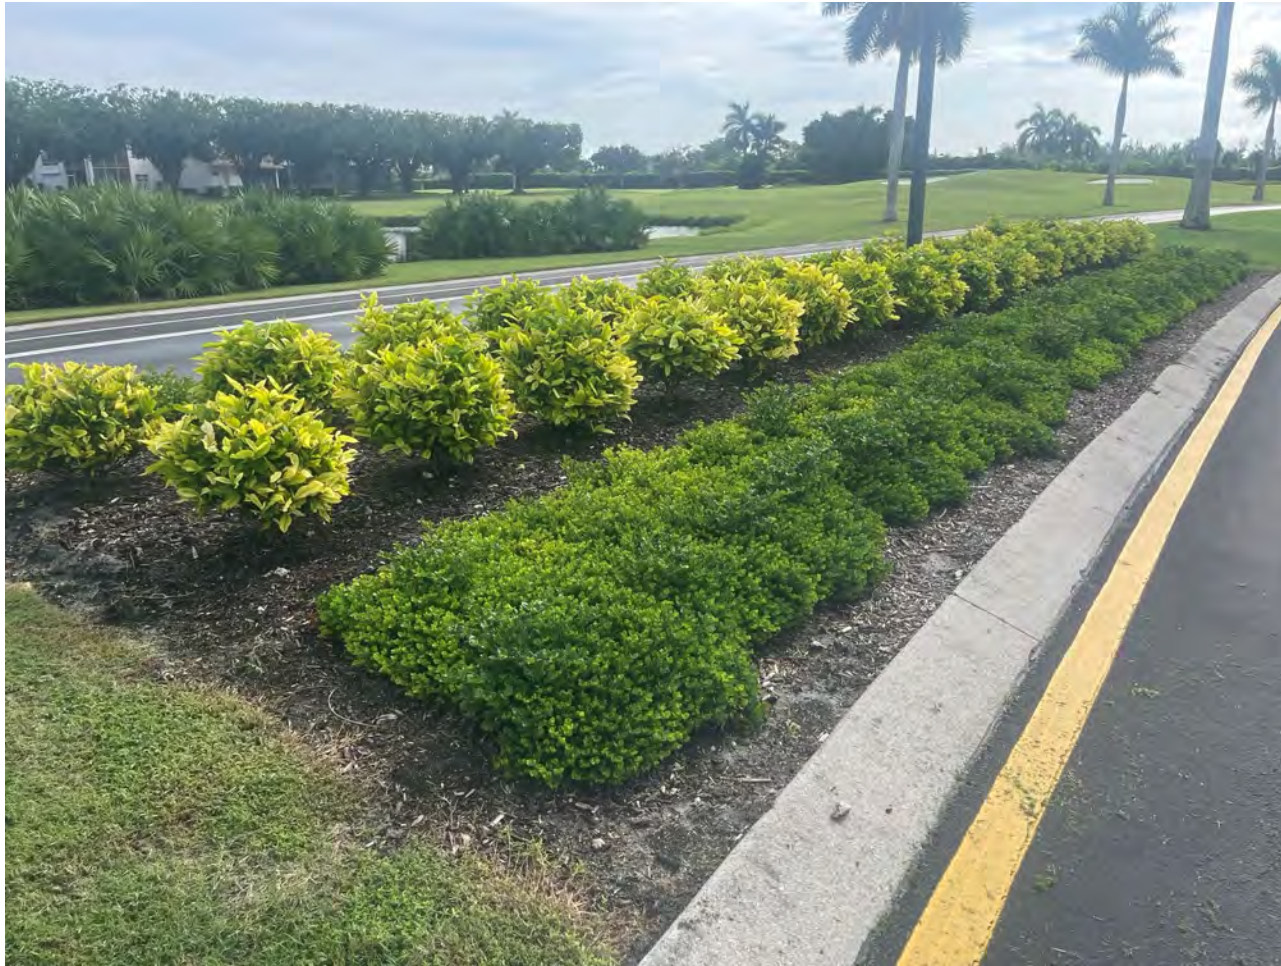
Lighthouse Lane buffer on East side of their lake was overgrown with Brazillian Pepper which was killing off clusia and Areca palms. Exotic clearing & trimming project is near completion. Involved trimming from Lighthouse Lane south to the canal on this lake.

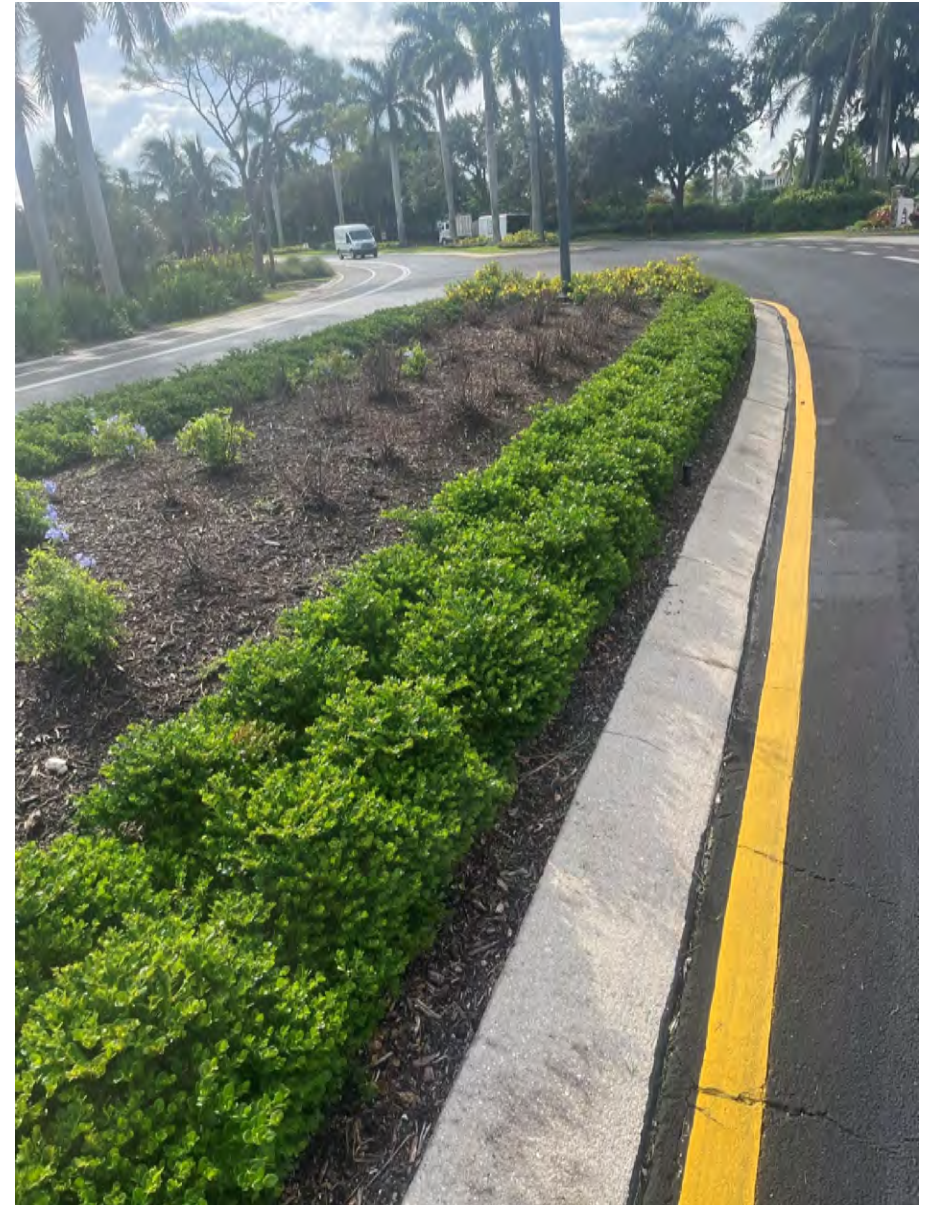
Committee assessing solution to non flowering median plants (ixora above). The Plumbago (right) were removed and replaced with Agave.

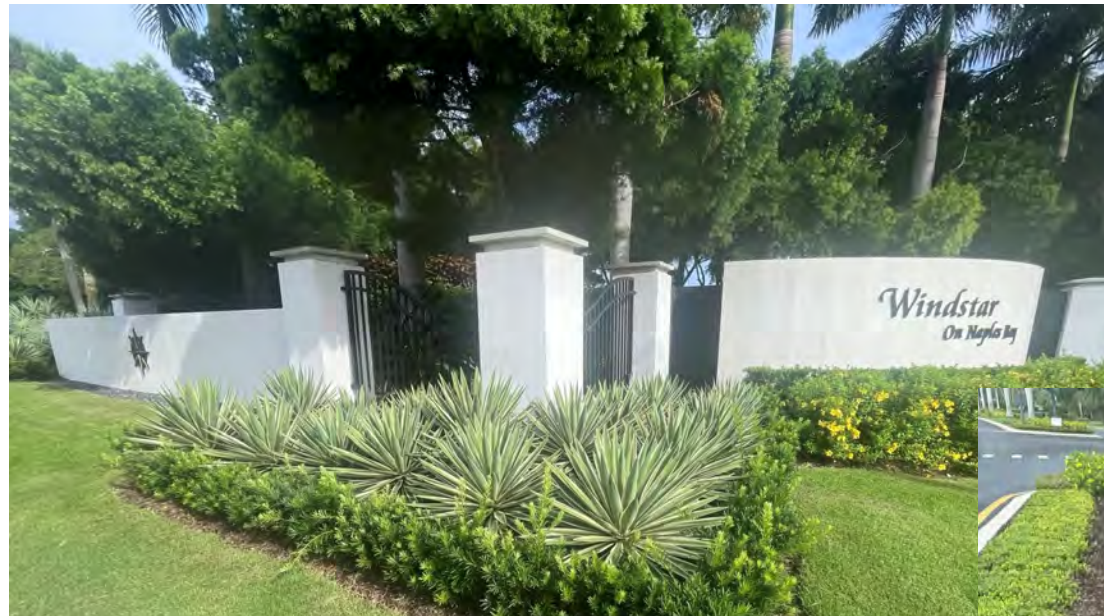
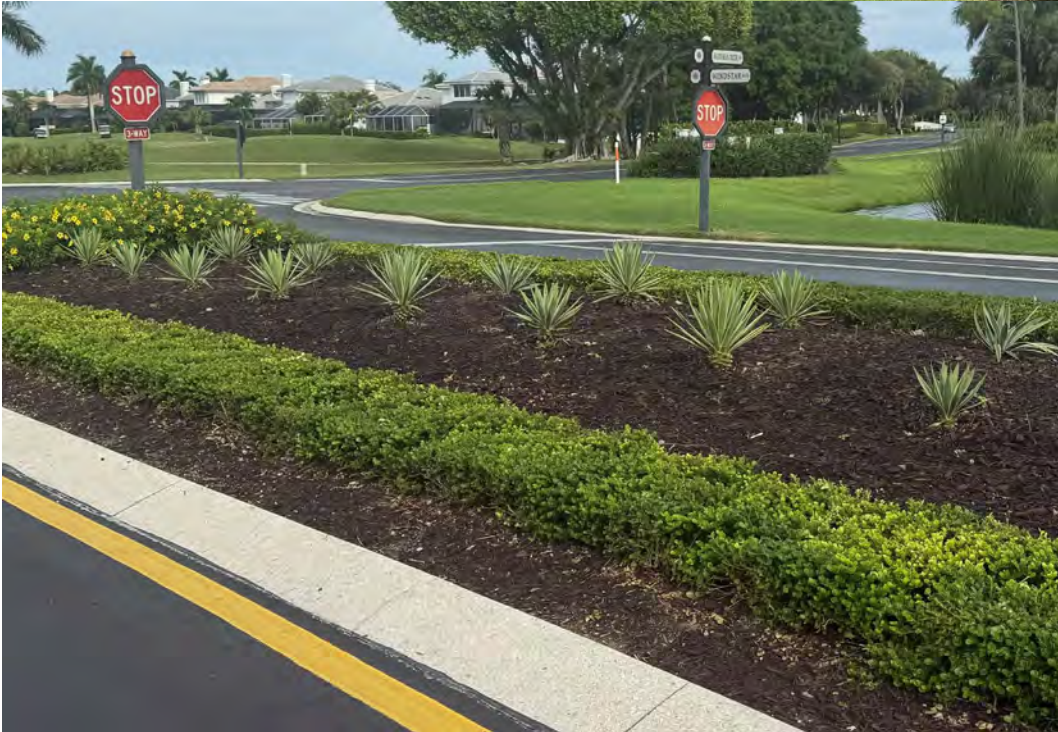
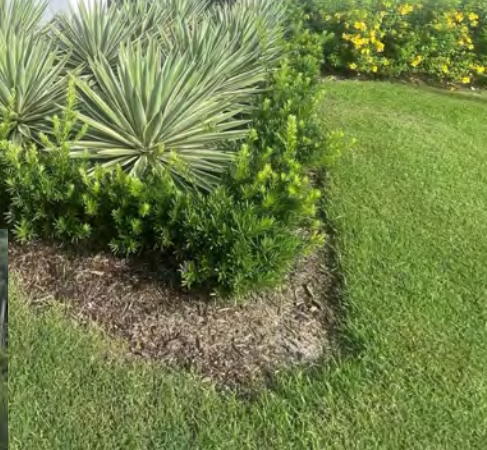
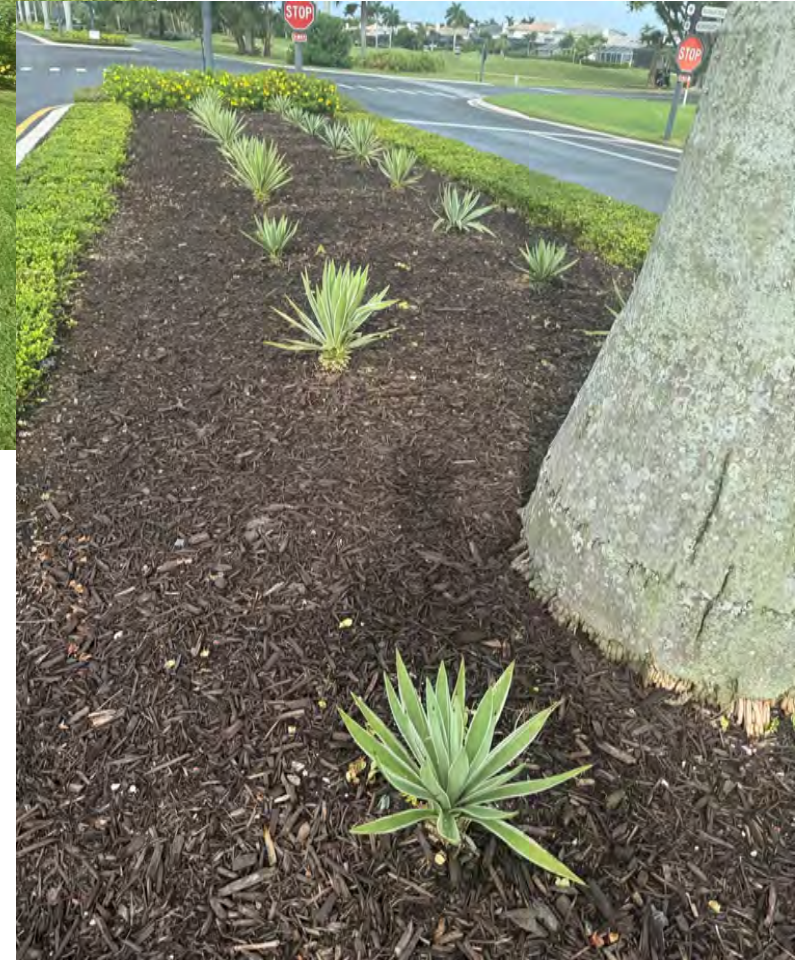
Front Entry Agave and green border to right has been emulated in median bull noses in photos on bottom of page
